Dinoseb (DNO) Impacted Soil Management Strategy

PROJECT SUMMARY

REMEDIATION PLAN

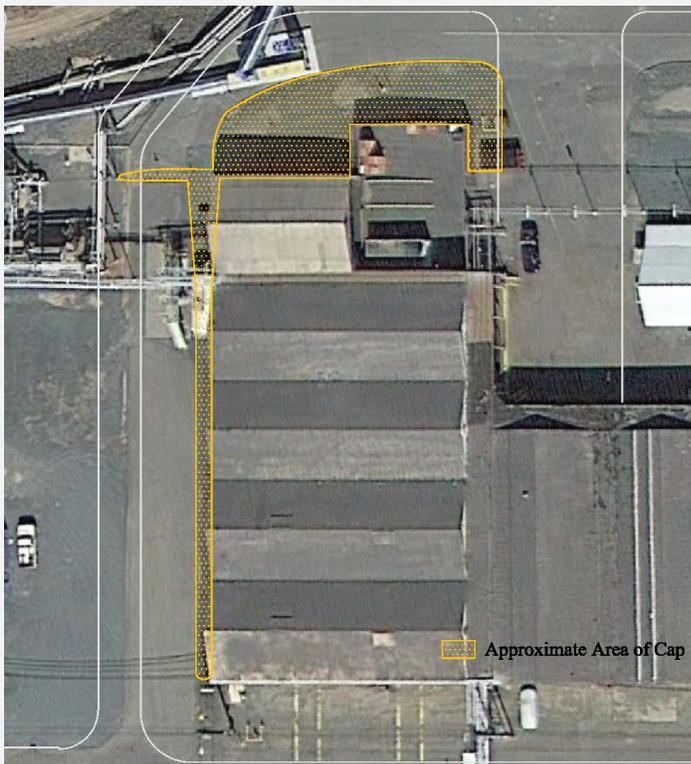
SITE PLAN

In December 2011, TEA conducted a soil investigation within an active chemical plant (warehouse and rail loading area) after the site personnel observed possible Dinoseb (DNO) contaminated material. Soil investigations were conducted to confirm the presence of and identify the horizontal and vertical delineation of DNO contamination within shallow soils. Soil sampling activities found DNO at levels that exceeded EPA Regional Screening Levels while delineating “hot spots” and distribution of DNO.

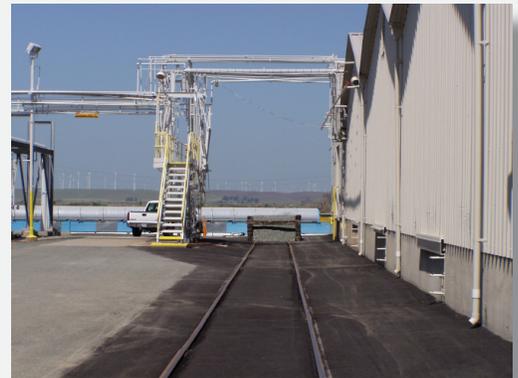
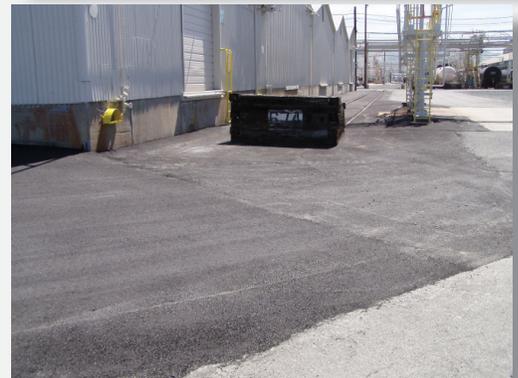
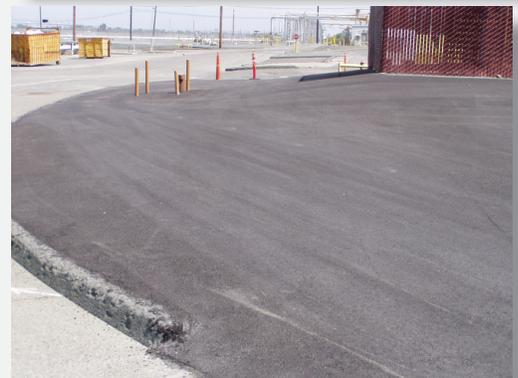
ASPHALT CAP

Site structures including a drain and a concrete pad were permanently removed from the site. Any visibly stained material that was potentially DNO contaminated was also excavated and containerized for disposal. The remediation area was then graded to establish a slope to allow for proper sheet-flow run-off of rainwater away from the remediation area. Following the establishment of the proper grade, an asphalt cap was constructed over the DNO-impacted area. All areas of the cap were completed to ensure a smooth and even finish.

Capping was selected as the preferred alternative due to the physical challenges of remediation at this location (i.e. risk of compromising the integrity of facility structures such as the warehouse and rails if excavation or soil mixing were performed), in addition to being the most cost effective means

to minimize worker exposure during remediation. A cap will function with minimal maintenance and promote surface drainage while eliminating erosion and rainwater infiltration. Capping will also not interfere with the continued use of this area of the chemical facility.
