**“A negotiated settlement agreement with the landowner resulted in a complete property restoration in an environmentally-sensitive region.”**

Oil & Gas Legacy Sites, Oil & Gas Remediation, Litigation

## PROJECT SUMMARY

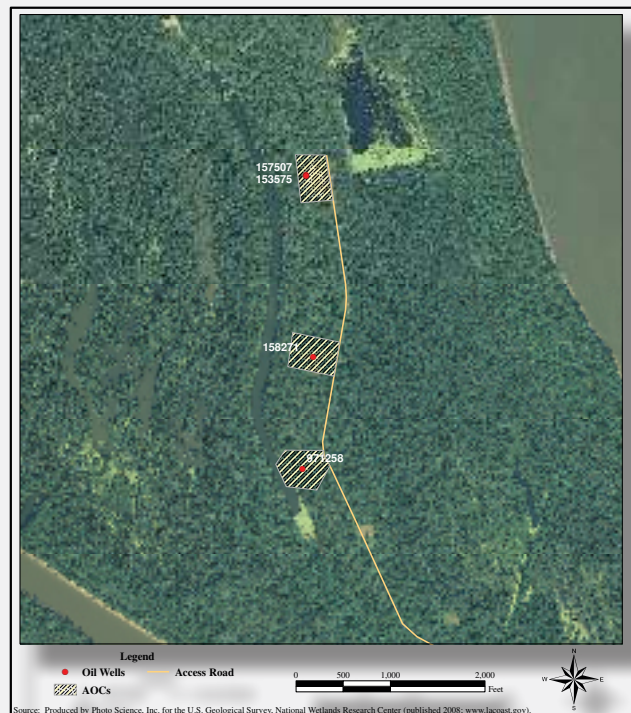
### WELL LOCATIONS

As a result of the site assessment, soils around two of the well heads required excavation and disposal due to elevated NORM readings. Additionally, nearly 3,500 feet of flow lines required cutting, surveying for NORM, and recycling. In preparation for the site closure activities, a wetlands permit was required. The initial phase was a NORM survey of each wellhead. Once the NORM-impacted soils were removed, clean backfill of similar material was placed in each excavation and compacted. The wetlands permit required that a “no net loss or gain” for site elevation be maintained. Each oil well was then plugged and abandoned according to DNR regulations, and the site re-graded to original elevation.

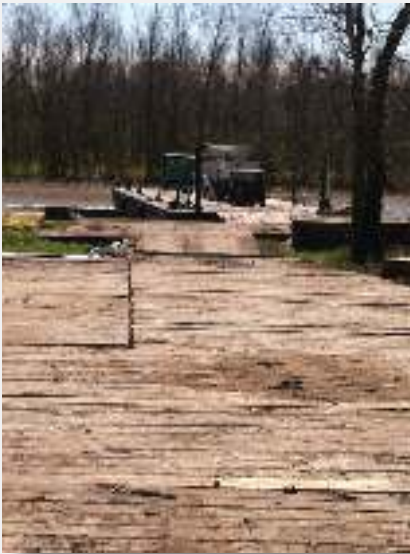
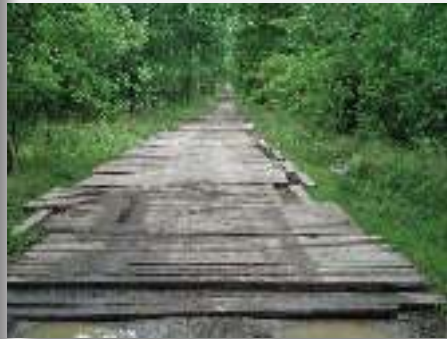
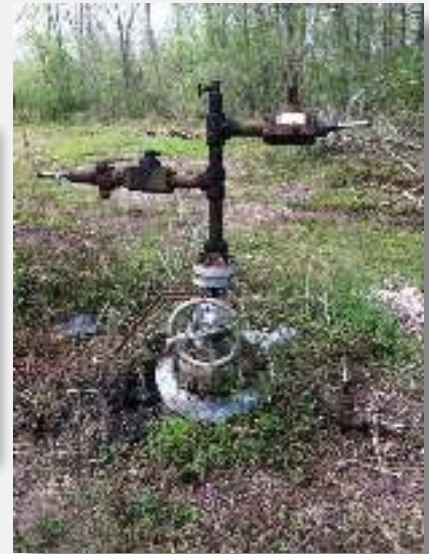
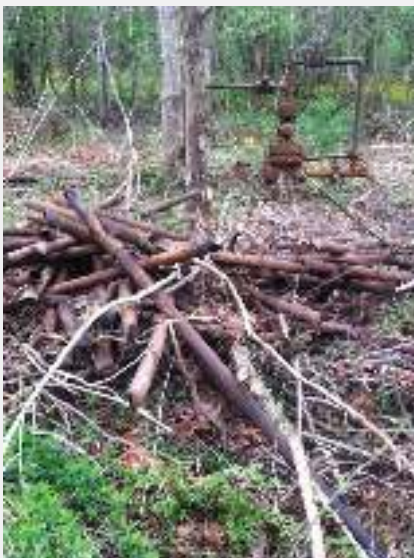
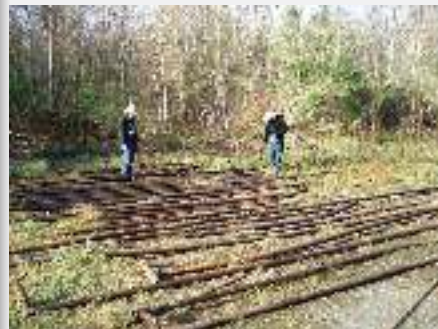
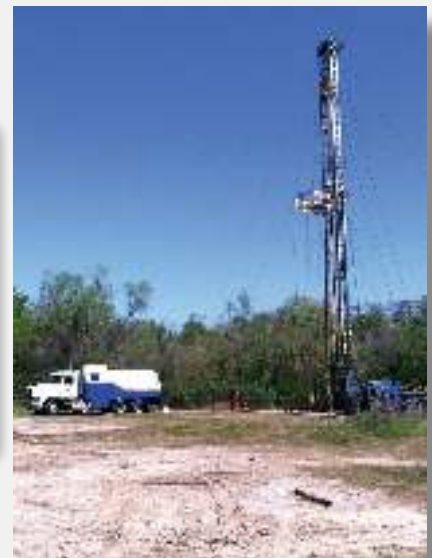
### REMEDIATION PROCESS

Site closure under 29-B consisted of removal of NORM-impacted soils, removal of debris (flow lines), and plugging/abandonment of four oil wells. The property has been successfully restored and placed back into use by the landowner as a wildlife management area.
